**Date:** May 2, 2017

**From:** Walter Remmert, Director  
Bureau of Ride and Measurement Standards  
Pennsylvania Department of Agriculture

**Subject:** **Investigative Report**  
**Amusement Ride Reopening Requirements**  
**Amusement Ride: *Rollo Coaster***  
**PA Ride ID Number: 1209**  
**7 PA Code § 139.11(c)(2)**

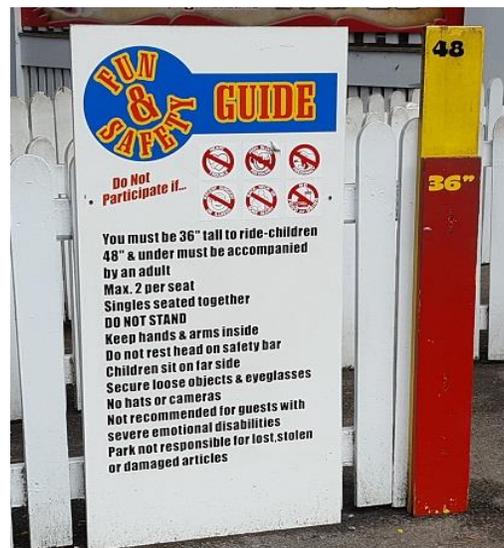
Photo "A" Entrance to Rollo Coaster

5. Neither seating arrangement would meet the Park's rule (photo "A") that requires an adult to be seated with a child between 36 inches and 48 inches tall.

6. The Park's rules for the Coaster, per signage at the queue line entrance (photo "A"), state "children sit on far side." This is interpreted as the smaller of 2 patrons in the seat must sit on the side away from the loading and unloading opening in the car. Both Operator 1 and Operator 2 failed to conform to the proper loading procedures and visual inspection requirements of seating prior to dispatching the train out of the station and over the lift.

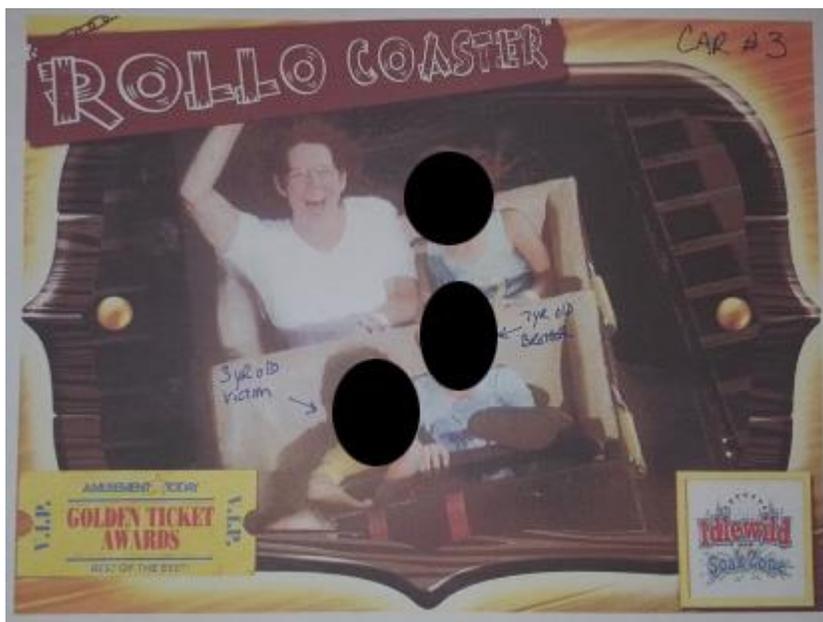
7. The train left the station, progressed up the lift hill and continued through the ride. An automated camera photographs each car on the downward slope of the lift hill as a souvenir sales option for patrons. Photo "B" shows the Subject Rider seated in the outside seat next to his brother. The Subject Rider can be seen holding on to the stationary grab bar with both arms around the bar.

Photo "B" Car #3: Subject Rider and brother in front

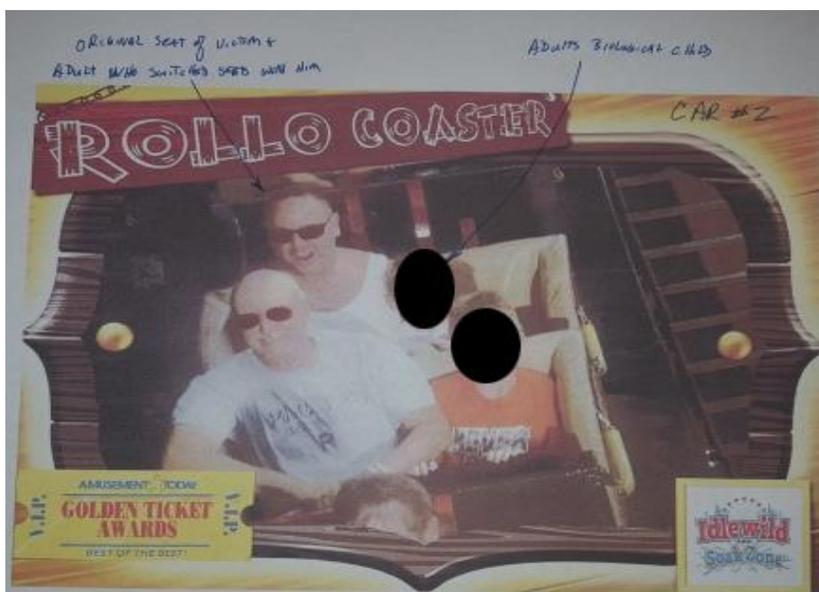
Photo "C" Car #2: Witness 1 in rear seat

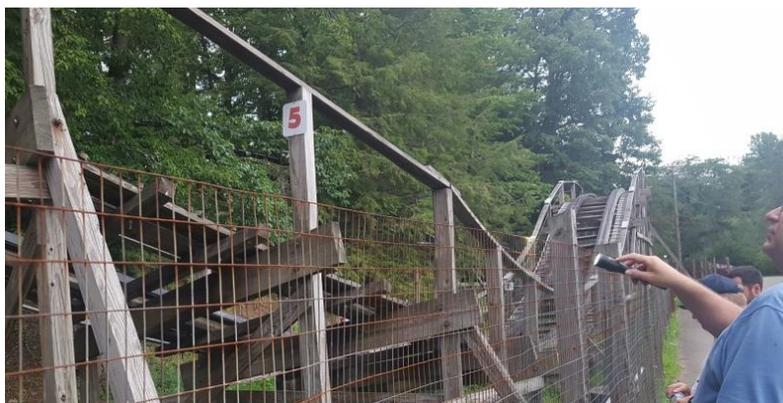
17. The Park's Safety Director, THOMAS PAOLA, assisted with the walkthrough and noted (pointed with his flashlight in photo "D") the location where evidence (forensic evidence, hair) was collected from the adjacent fence and structure (near white placard with a red "5"). The Subject Rider was found on the ground below.

Photo "D" Area adjacent coaster where Subject Rider

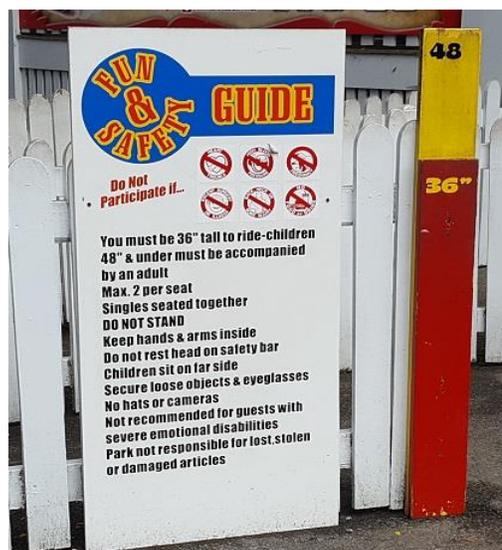
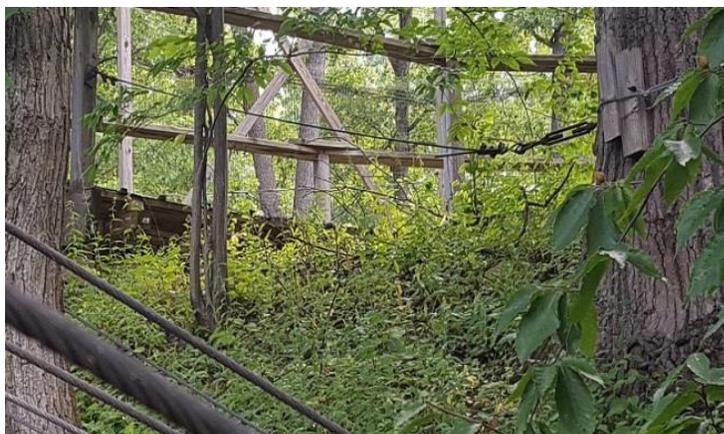
31. A structural support cable running to the beginning of the curve in question was observed to be loose and sagging. The turnbuckle to cable is rusted with no jam nut (Photo “E”).

Photo “E” Structural restraints for track

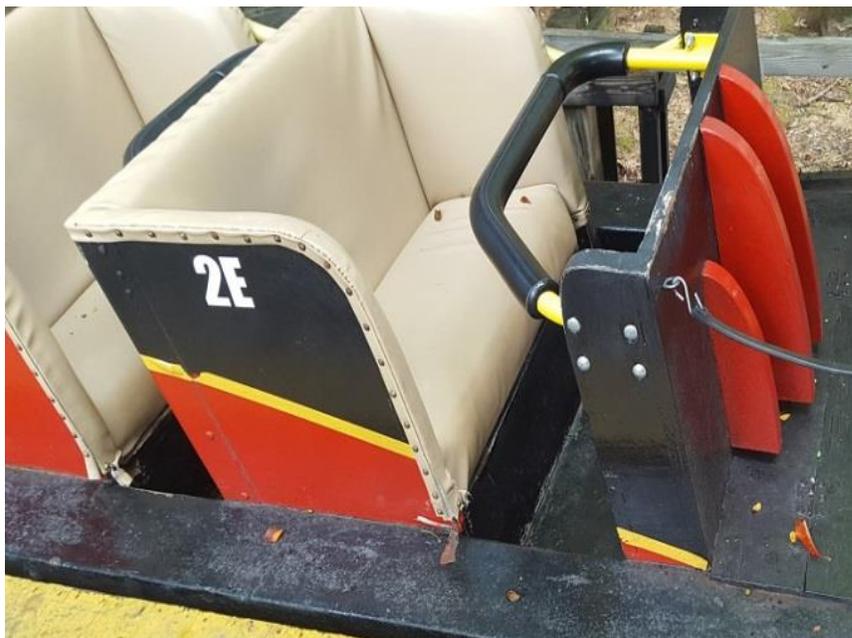
33. The stationary “Grab Bar” shown below is a primary restraint. The phrase “REMAIN SEATED – HOLD ONTO BAR” is printed in large upper-case letters on the back of each car, instructing riders to grip the bar while the Coaster is in motion (Photo “I2”). There are no seat belts to act as a secondary restraint. (Photo “F”).

Photo “F” Train #2, row 2E (Subject position)

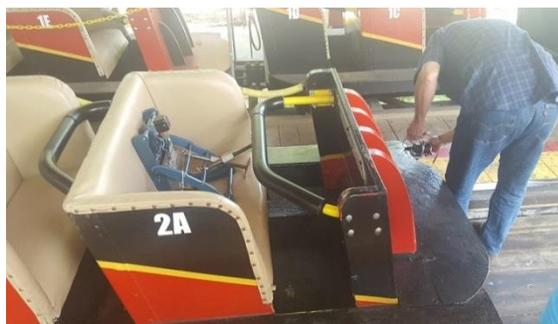
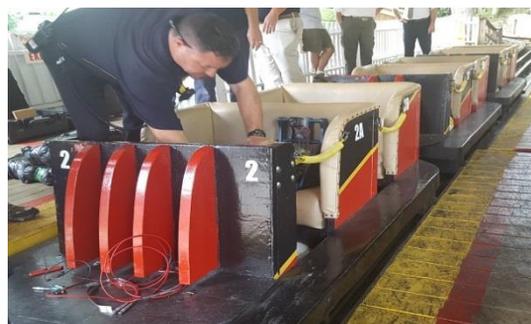
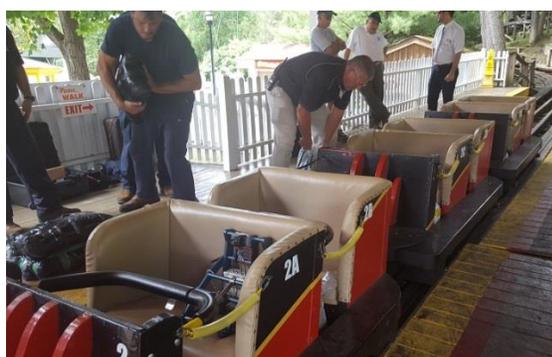
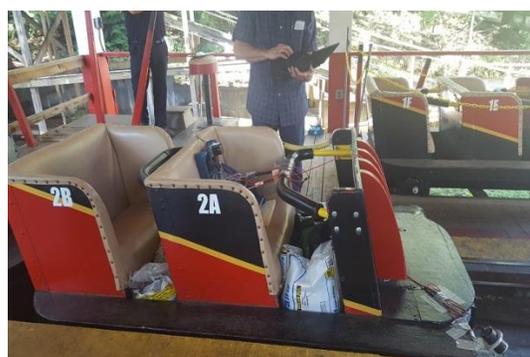
34. See photos below of GMH Engineering preparing for and conducting the accelerometer testing on August 12, 2016 (group of 4 photos, Photo “G”). The Department received the results on October 24, 2016.

Photo “G” Preparing for accelerometer test

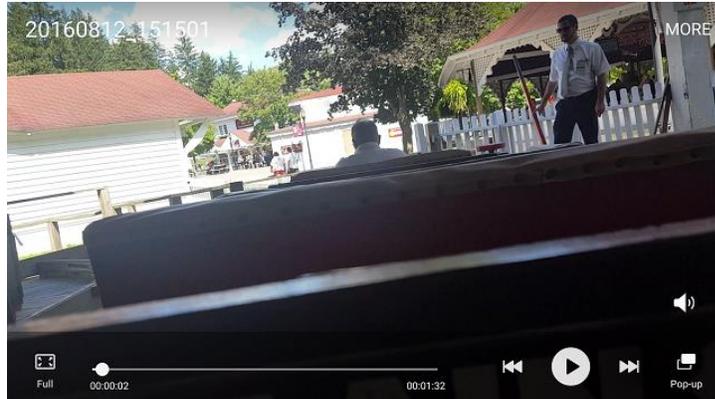
37. Operator 1 has a clear line of sight as the train passes his position. He also has clear line of sight as the train starts to climb the lift hill (Photo “H” and Photo “I”; Video – Coaster test run 1).

Photo "H" Rear of train looking forward at station

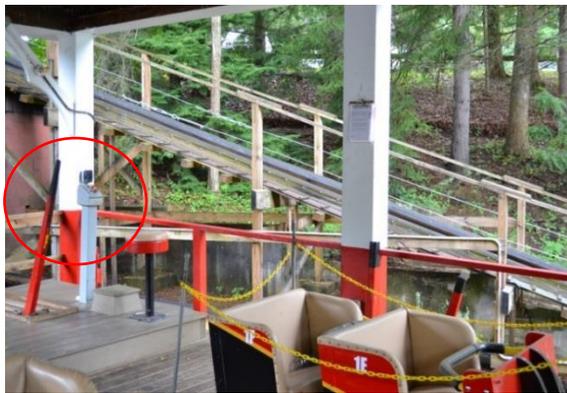
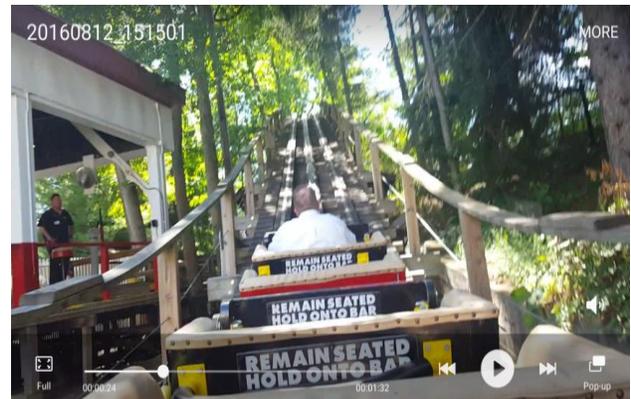
38. Operator 2 has clear line of sight of the dispatch area (station), the initial curve to the lift hill, and the lift hill. A mirror positioned over Operator 2’s area allows him to assist with watching the loading area. Operator 2’s area has the controls to stop the train prior to descending the lift hill, if necessary.

Photo "I" & "I2" Operator has view of loading and hill with controls to stop the train

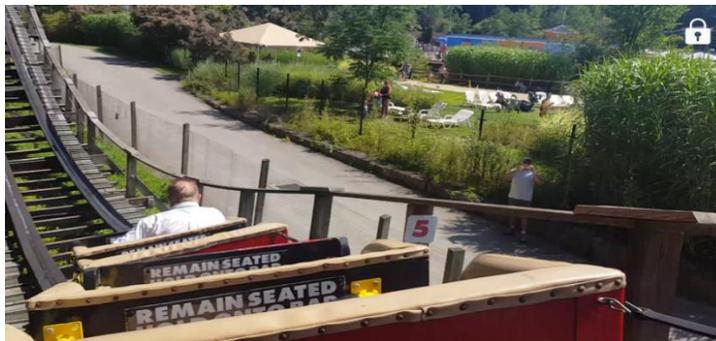
39. The screen shot below from the video shows the location where there is a left-right movement in the car toward the end of the curve where the #5 is posted. Just in front of the #5 is the approximate location where the Subject Rider fell out (at 60 to 61 seconds in the following video - below the screen shot).

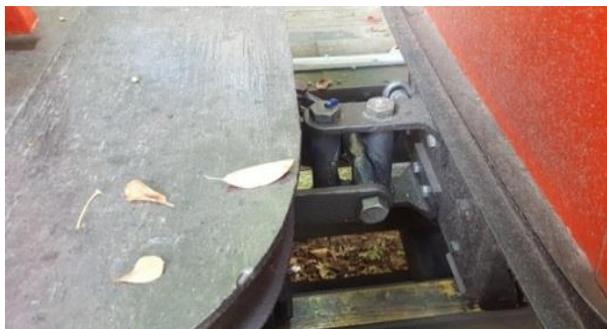
41. The couplings on this type of coaster consist of three hardened bolts (two of which are vertical, with a third bolt positioned horizontally between them) that are sleeved with steel pipe that acts as a wear surface that also limits movement between the cars. The photo shows wear in the steel pipes (car #2 and car #3 of train 2). (Photo "J")

Photo "J" Coupler between car #2 and #3

- Worn train hitches. Wearing and deterioration of the steel pipe wear surfaces that sleeve the hardened bolts in the coupling between the cars involved in this incident allows for greater movement between the coupled cars than if the wear surfaces were completely intact. A photo of the bolts between car #2 and car #3 of train 2 shows the extent of the wear in these steel pipe wear surfaces (Photo “J”).

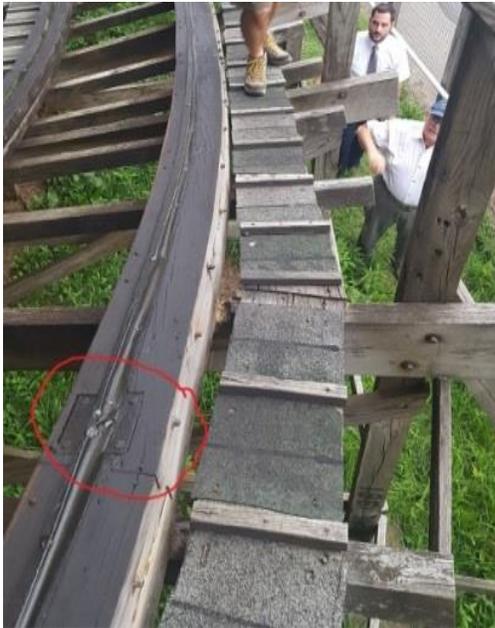
45. Photos “M” and “N” depict the approximate site where the incident occurred. Noted in the photos are areas of structural wear and tear, which is consistent with track movement while the Coaster is in operation as seen in the previous video (video – coaster run with sandbags 1).

Photo "M" Top rail splice pointing 'in' toward direction of travel.

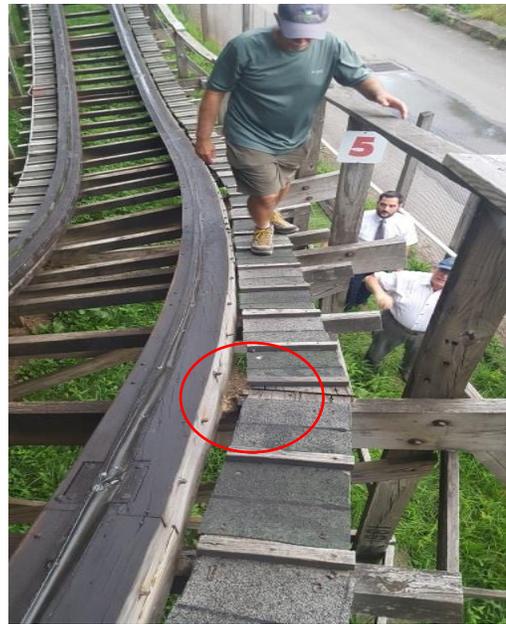
Photo "N" Structural movement at site

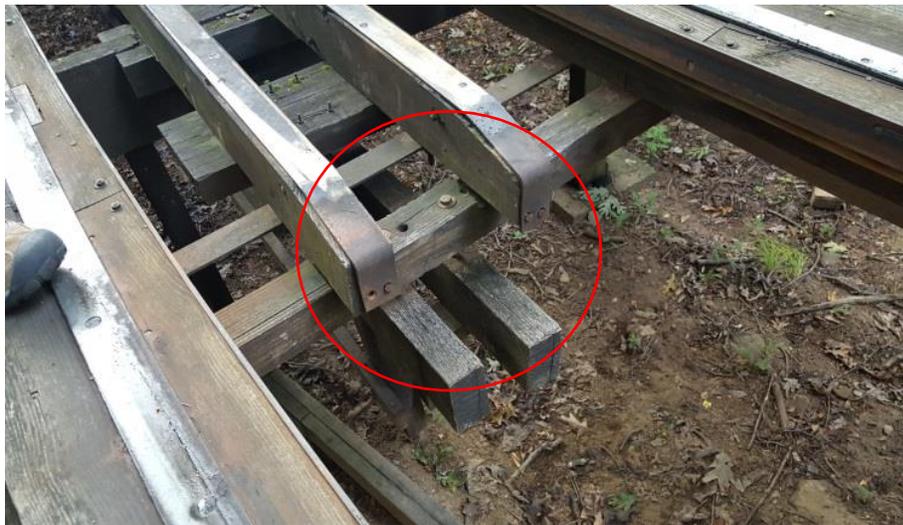
46. Photo "O" depicts the need for regular maintenance on the sled brake assembly. Note the missing bolts at the ends of the brake bands and other hardware that require replacement and/or tightening.

Photo "O" Brake assembly

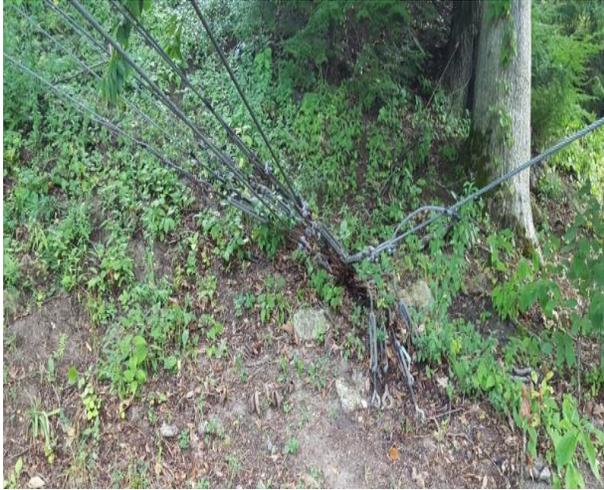
47. The turnbuckles and cables in the curve where the incident occurred are intended to provide radial stability to curves on Philadelphia Toboggan Roller Coasters. Several turnbuckles were found to be lying on the ground unattached. The cable attaching assembly is buried in vegetation and overgrown. One cable was attached to a tree.

Photo "P" Turnbuckle for incident

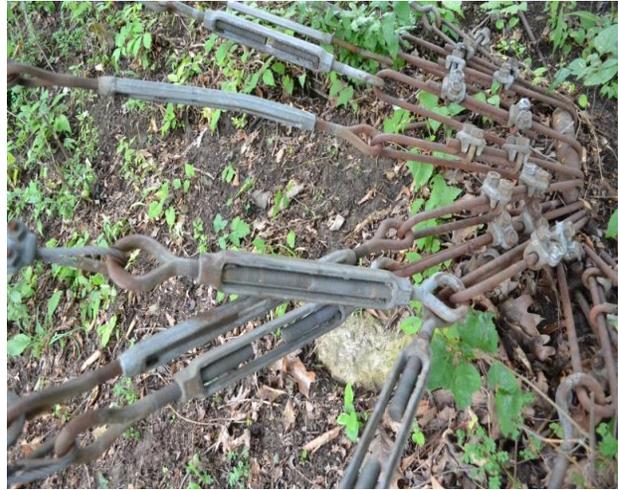
Photo "Q" Turnbuckle alternate view

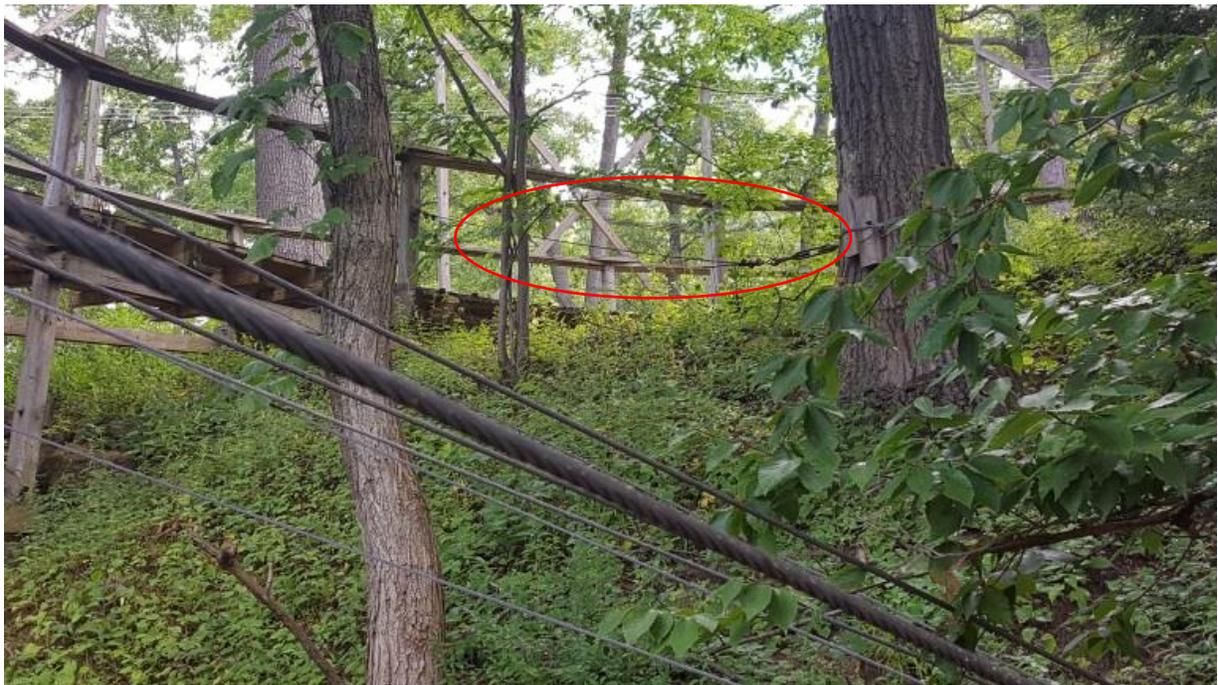
48. A cable and turnbuckle attached to a tree sagging, rusted, and unable to be tightened.

Photo "R" Turnbuckle and cable attached to tree

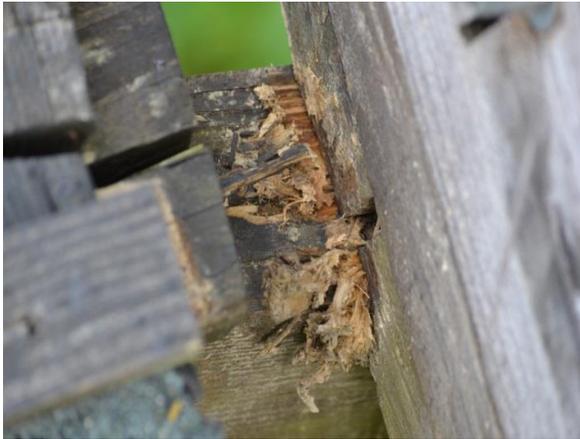
Photo "S" Depicting track movement

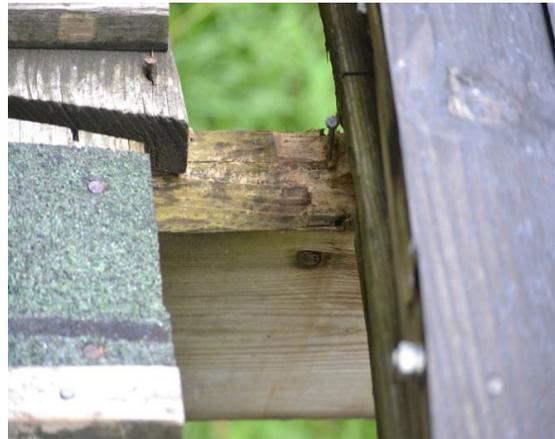
Photo "T" Shows nail and movement

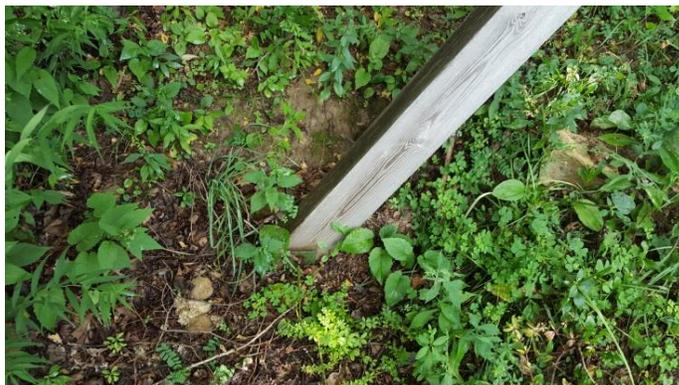
54. Batter brace buried.

Photo "U" Buried bracing for bent

- Movement of the track and structure as shown in this report.
  - Maintain/remove dirt and debris from all footings of the Coaster to ensure the footings and connections are serviceable and to prevent structural deterioration.

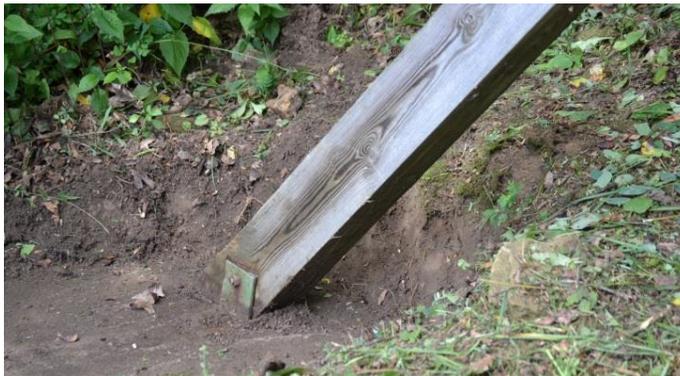
55. Batter brace cleaned showing movement.

Photo "V" Cleaned brace showing movement

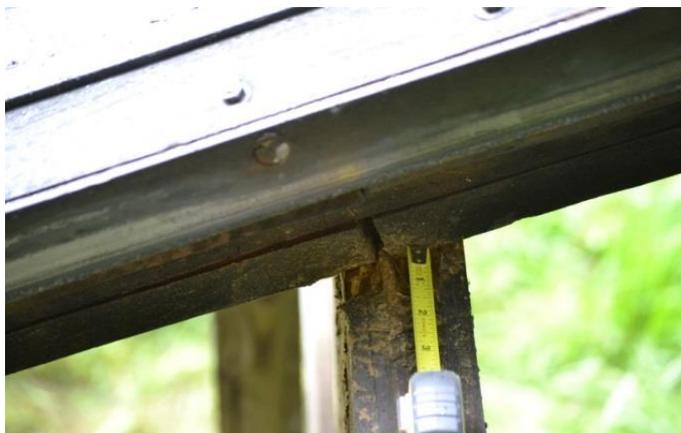
56. Tape measure shows amount of movement of the track on the ledger.

Photo "W" Track movement

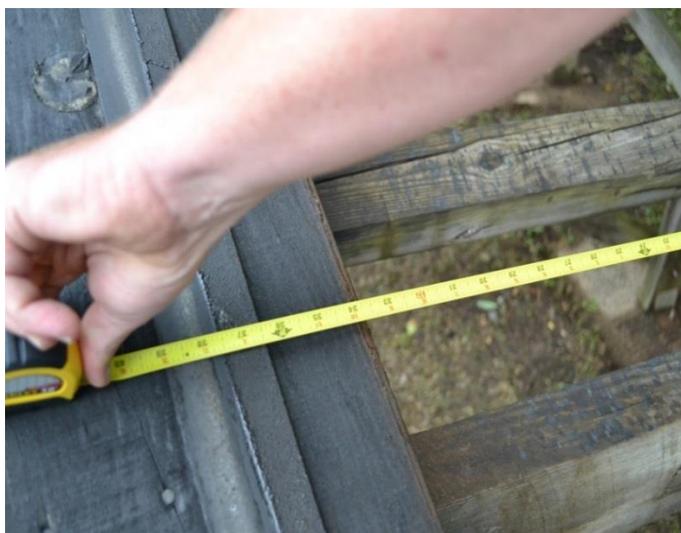
44. The track gauge measurement at the curve involved in the incident was 33 1/2” to 33 3/4”. The standard gauge noted by manufacturer requirements is 33” +/- 1/4” maximum tolerance. (See Photo “X”)

57. Track gauge measurement.

Photo "X" Track gauge measurement

- Track/wheel gauge. Philadelphia Toboggan Company advises the Department that the *track gauge* for its roller coasters should be 33.25 inches and that the *wheel gauge* for its roller coasters should be 33.” *The Rollo Coaster’s* track gauge varies up to 33.75” (as shown). Increased track gauge effects the speed and tracking of the train and can cause movement that would not otherwise be present if the track gauge was within the limits presented by the Coaster’s manufacturer, Philadelphia Toboggan Company.

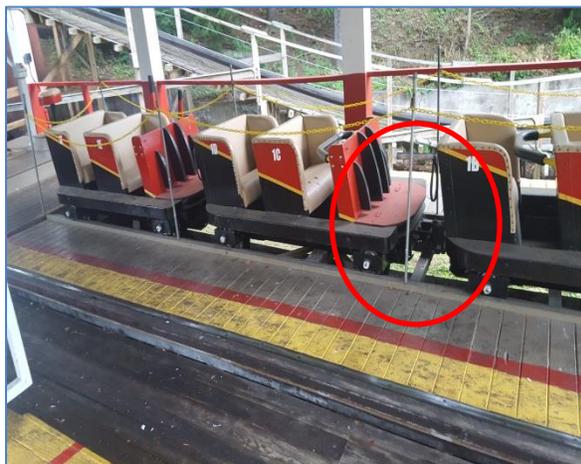
58. Coaster train #1, which has been out of service for quite some time. Hitches can be seen unattached and no safety chain installed.

Photo "Y" Coaster train #1

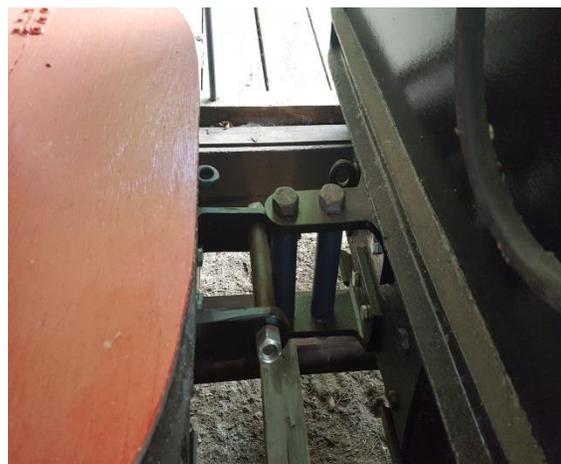
Photo "Z" Train #1 hitch attachment
